Water Compliance Inspection Report

Water Compliance Evaluation Inspection Potomac Electric Power Company, Inc. Benning Road Generating Station 3400 Benning Road, NE Washington, DC 20019

NPDES Permit No. DC0000094

May 6, 2015

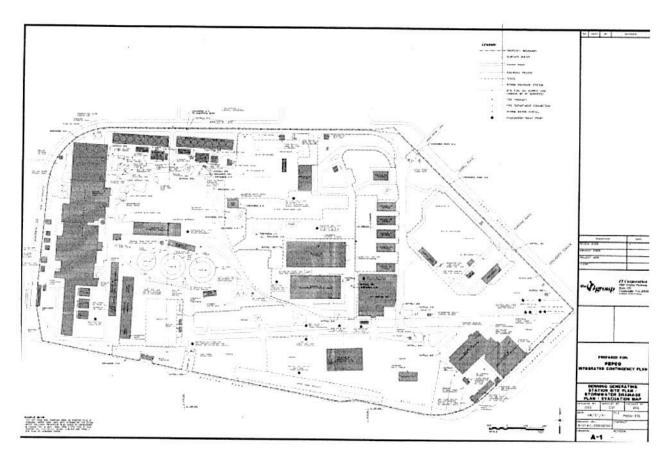
Figure 1: PEPCO Benning Generating Station – site plan and stormwater drainage plan.

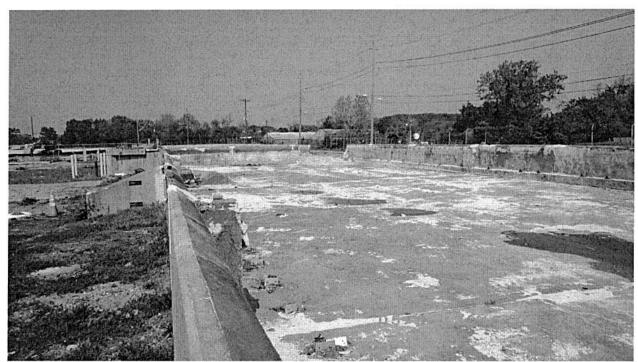
Photo 1: The cooling tower substructure. This area is scheduled to be removed before the end of May 2015.

representatives stated that the closure will be done in accordance with all environmental regulatory requirements established by the District of Columbia and federal agencies. It is estimated that plant closure will be completed by the end of May 2015. During the inspection, the only items that remain to be completed were removal of the cooling tower substructure and minimal site restoration activities (**Photos 1 and 2**).

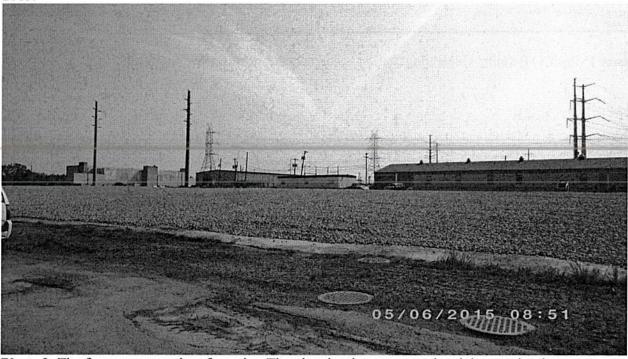
Photo 2: The former power plant footprint. The plant has been removed and the area has been regraded and stone has been placed on the surface to prevent erosion.

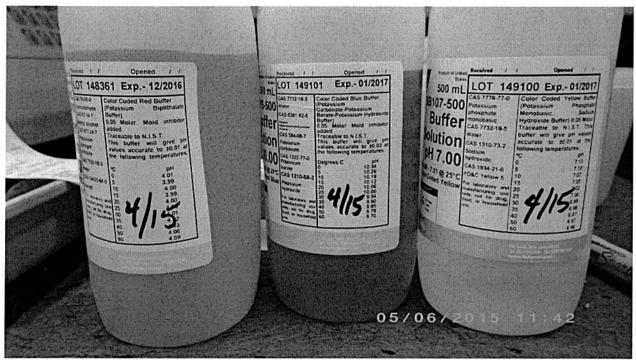
Photo 3: Non-expired pH buffers in the in-house lab at PEPCO.

Samples collected for analyses of oil and grease (O&G), total suspended solids (TSS), PCB Aroclor, and metals are picked up the same day or the following day by courier and transferred to Microbac Laboratories, Inc. (Microbac) in Baltimore, Maryland. Samples collected for analyses of PCB congeners are sent to Cape Fear Analytical, LLC (Cape Fear) in North Carolina. A review of the chemical lab's calibration log books indicated the use of a 3-point procedure to calibrate its pH meters every month. The pH buffer solutions used in the calibration were all current at the time of this inspection (**Photo 3**).

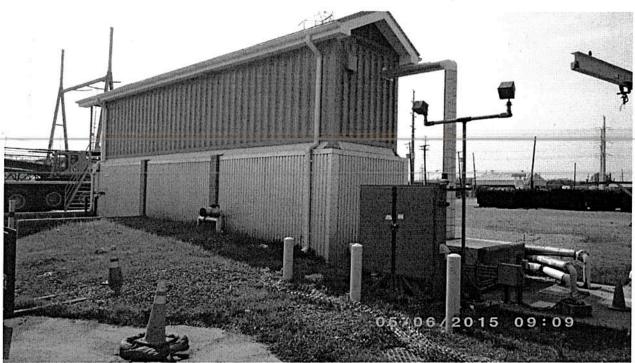
Photo 4: Oil-water separator at Outfall 201, installed in 2011. Facility representatives stated that the current plant is to continue to use the separator to treat stormwater accumulated from the area.

- (i) Oil-water separation/settling system at Outfall 201 was designed to remove oil and grease from utility wastewater and a No. 2 fuel oil loading area. Monitoring point 201 is the discharge point from this oil-water separator. In 2011, the facility installed a new oil-water separator system, which is currently operational and in-service (**Photo 4**.). Facility representatives stated that, currently, it is the plan to maintain this oil water separator for the treatment of stormwater.

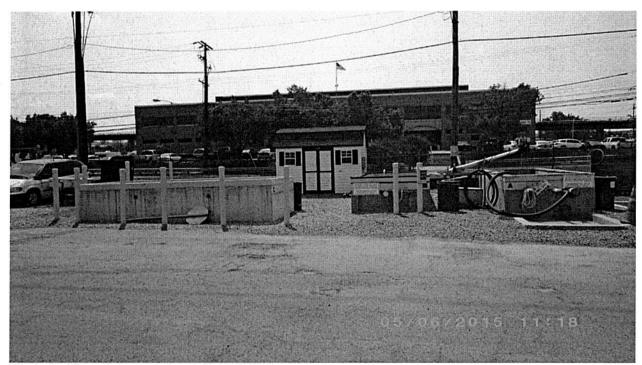
Photo 5: Oil-water separator at Outfall 003.

- (ii) Oil-water separation/settling/filtration system at Outfall 003 is a treatment system designed to remove oil, grease, and solids from water that is removed from utility manholes throughout PEPCO's service area. The treatment system operates in batch mode and consists of an oil-water separator, storage, and settling tanks followed by a two staged filter system of cloth and charcoal media (**Photos 5, 6, and 7**). The treated effluent is held in an underground tank from where it is sampled, and upon receipt of analytical results showing that no contaminants are present above effluent limits is pumped as a batch through Outfall 003 to the Outfall 013 pipeline. If necessary, pH is adjusted before discharging. At the time of the inspection, the treatment system was not discharging to Outfall 003. The facility representatives stated that the two on-site oil-water separators will not be removed as part of the plant closure procedures.

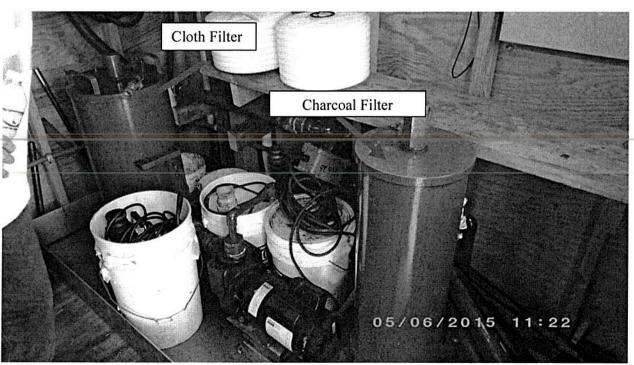
Photo 6: A two-stage filter system as part of the oil-water separator treatment system at Outfall 003.

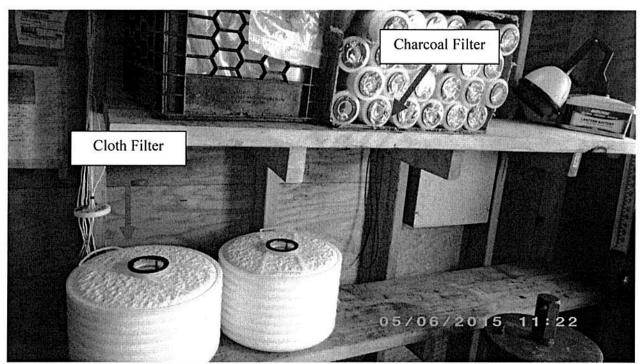
Photo 7: Charcoal and cloth filters used in the oil-water separator at Outfall 003.

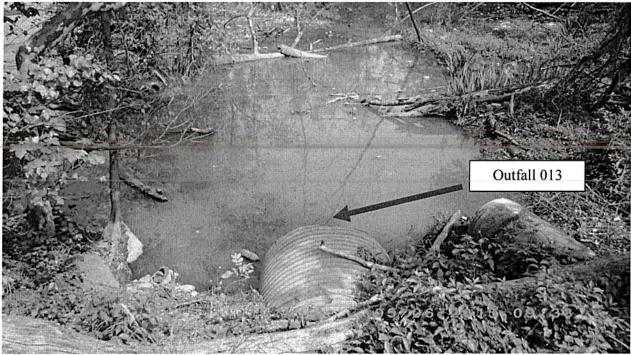
The outfall discharges into a wetland, a few hundred feet from the Anacostia River. Outfall 013 was not observed discharging water during the CEI. The receiving water at the discharge point of 013 was brownish in color and turbid or cloudy in appearance. It was not apparent where the turbidity originated from but it did not seem to be directly related to the outfall. There are other outfall pipes adjacent to Outfall 013 which apparently discharge stormwater from nearby areas of the District.

Photo 8: Outfall 013 at the Anacostia River (receiving waters). Notice the additional Outfall pipe on the right.

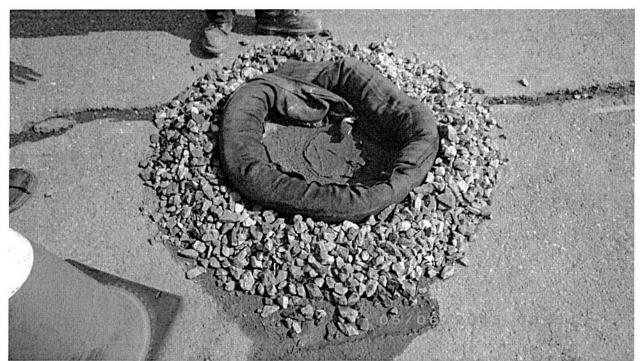
Stormwater runoff from the facility is conveyed through a drainage system and is discharged to the Anacostia River and the Districts Municipal Separate Stormwater System (MS4) at various outfalls. Most of the stormwater runoff from the PEPCO's service center area is conveyed through a 36-inch and 54-inch storm drainpipe to the Anacostia River via Outfall 013 (Photo 8). The monitoring/sampling location for Outfall 013 is located near the property boundary within the PES power plant area and is located approximately 500 ft from the point of discharge into the Anacostia River (end of 54" outfall pipe). Stormwater catch basins within the demolition area have been covered with filter cloth, oil absorbent booms, and rip-rap to remove excess debris generated during demolition from entering the basins (Photo 9).

Photo 9: Storm sewer catch basins located in the work area have been marked, protected with rip-rap and oil absorbent boom. Upon completion of construction the basins will be fitted with metal-sorbent filter fabric and boom.

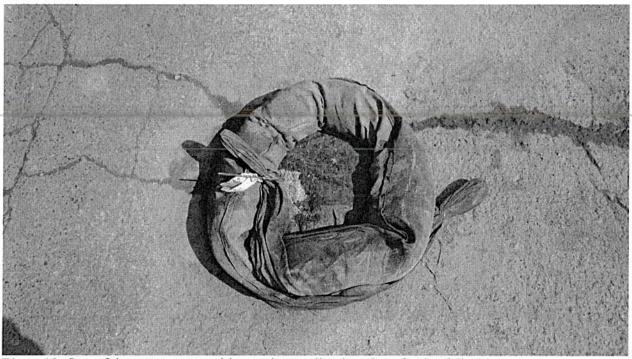
The NPDES Permit (DC0000094) also authorizes the facility to discharge stormwater from Outfall 101, whose drainage area includes the transformer area on the west side of the power generating building (power plant). Manhole K, the original monitoring/sampling location for Outfall 101, has been eliminated because tidal influence from the river often made representative sampling difficult. In accordance with the reissued permit's compliance schedule, the facility has developed an alternative to sample collection at the Manhole K location, which consists of compositing grab samples from 7 upstream storm drains on the west side of the power plant that discharge to Manhole K (Photo 10).

Photo 10: One of the seven compositing grab sampling locations for Outfall 101.

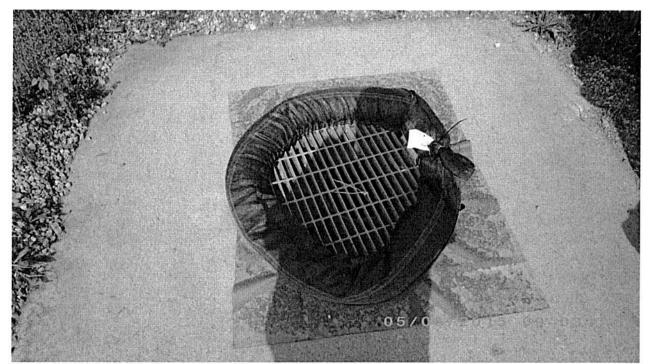
Photo 11: Phase III best management practices implementation – metal-sorbent filter fabric and boom placed over stormwater catch basin.

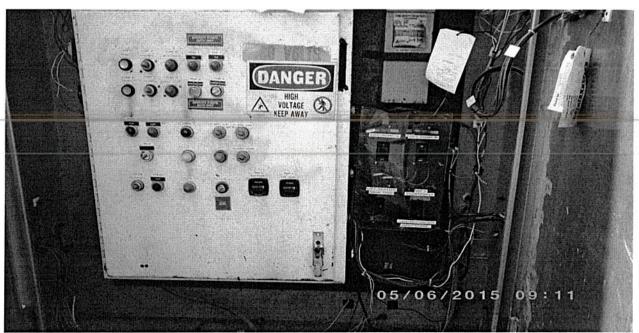
Outfall 201 is a major internal monitoring and discharge point for the facility's industrial wastewater and some stormwater. A duplex pump system (each rated at 500 gpm) intermittently pumps the stormwater and wastewater from the various power plant related processes to the new oil/water separator that has been in operation since March 31, 2011. According to the facility representatives, the system has a surge valve which would bypass treatment and flow directly to Outfall 201 if ever activated. They pointed out that the valve is kept in a locked position. As noted above, Outfall 201's flow is estimated by metering running times (hours) of the oil water separator's 2 influent pumps and applying their pump ratings to calculate its flow.

Photo 12: Control panel for oil-water separator's influent pumps, which includes running time (hours) meters used to estimate flow at Outfall 201.

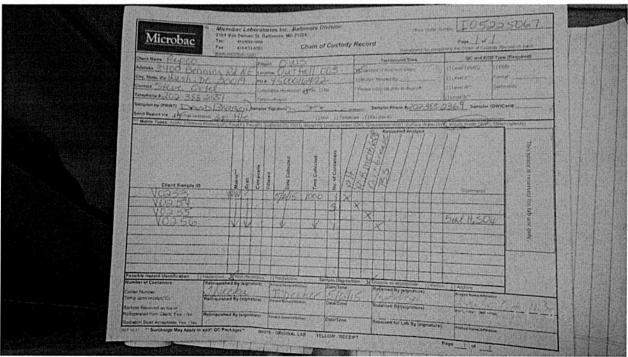
Photo 13: Chain of custody forms used by PEPCO (Chemical Lab).

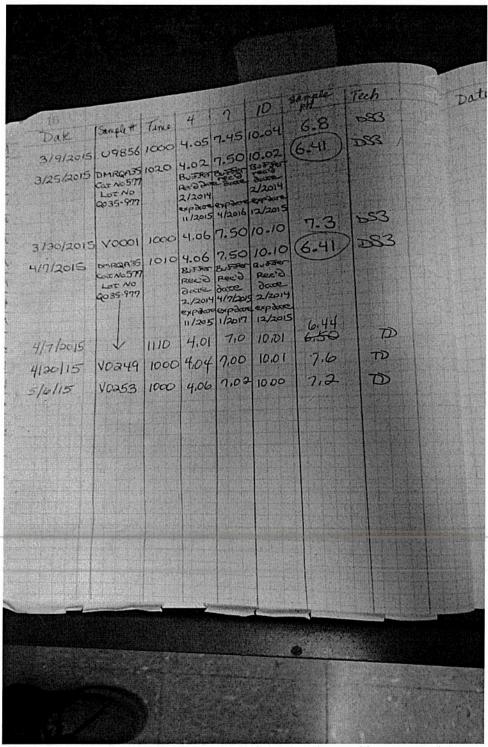
Photo 14: Up to date calibration records for pH probe used by Pepco's lab.

- PES personnel use the small PES storage area to analyze the facility's NPDES permit effluent samples for residual chlorine and pH. They also collect TSS, Oil & Grease, PCB, and Metals samples which they preserve, as necessary, and refrigerate before shipment to Microbac or Cape Fear laboratories. PES personnel monitor Outfalls 013 and 201. As noted earlier, PEPCO has contracted AMEC to monitor Outfall 101 (Manhole K) during storm events. The pH buffer solutions used in the calibration were not expired at the time of this inspection; calibration records were up to date.
